**UNIVERSITY OF MICHIGAN STADIUM
IPANEX MODIFIED REPAIR MORTAR**

1972 – 2001

In the spring of 1972 a program was started to rehabilitate the entire interior concrete surface of the University of Michigan Stadium. The risers and tread surface were severely deteriorated or spalled in much of the 460,000 square feet of concrete surface.

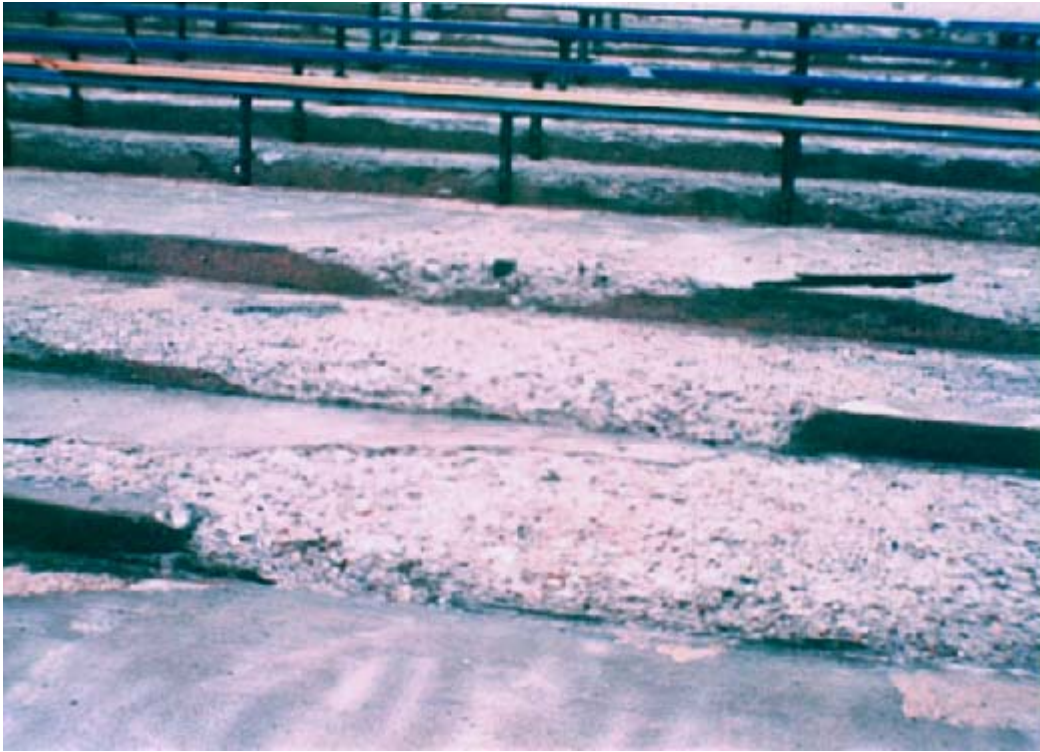
Circa 1972, fifty-yard line (after seats had been removed on the first three rows).

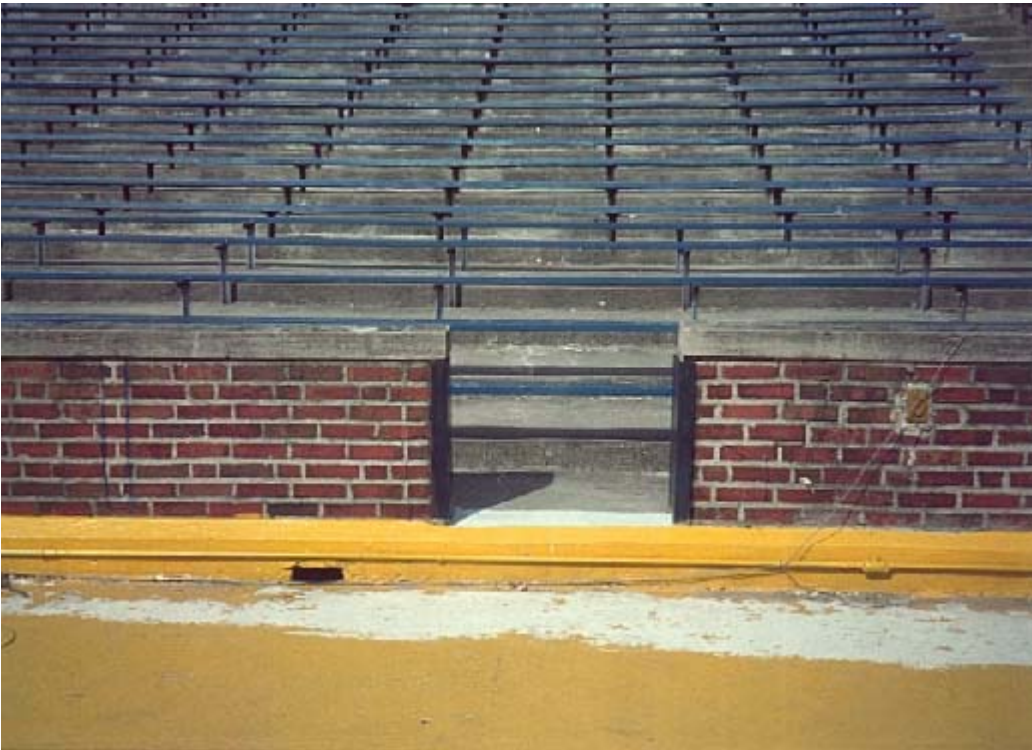
Photograph taken circa 1989.
Same location after repair completed.

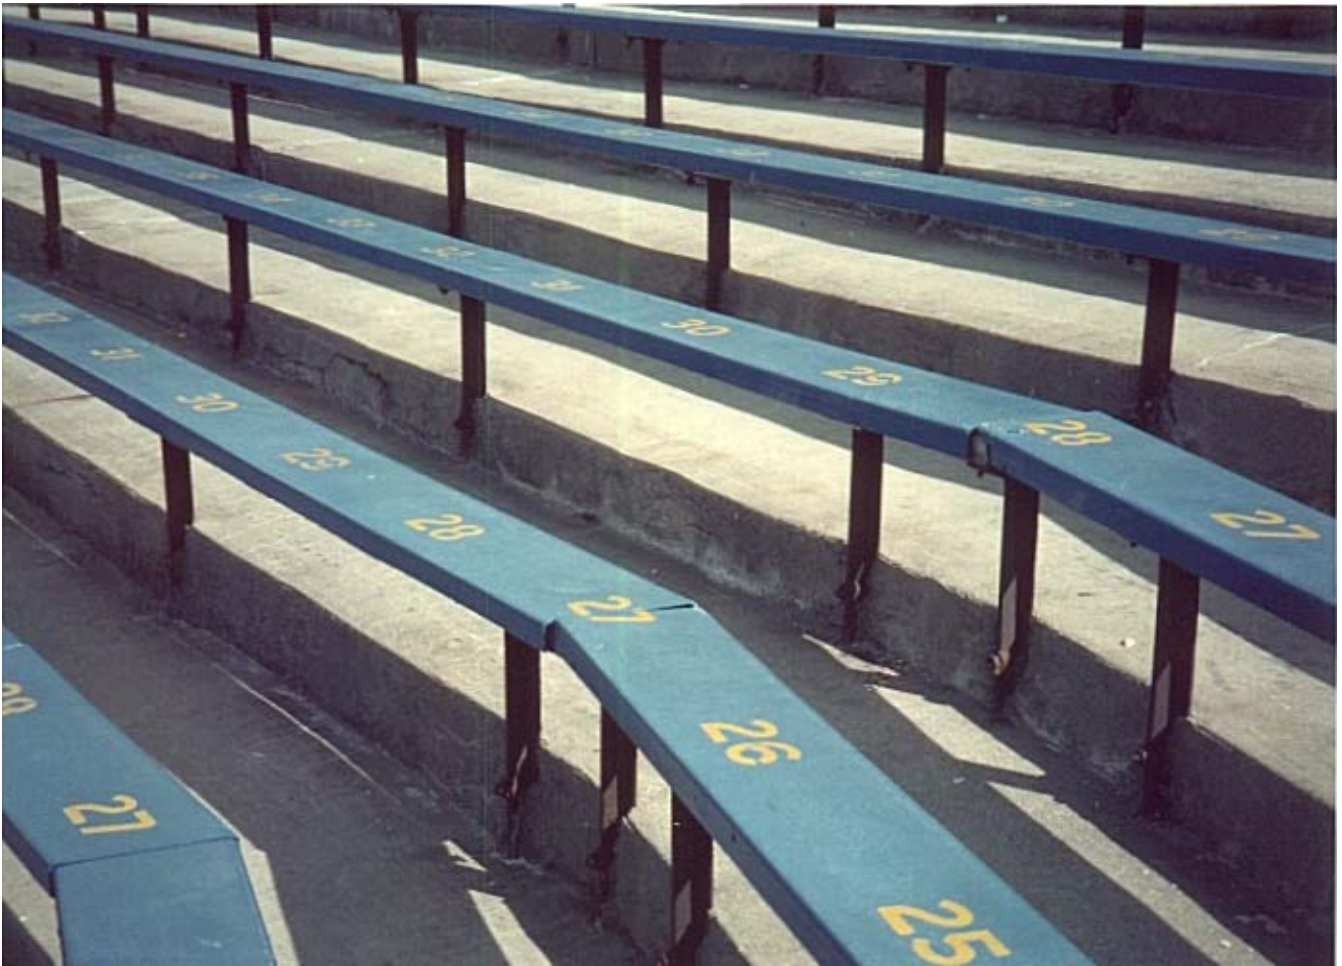
Photograph taken April 1990.

The repairs were made circa 1972 – 1973.
Note that stanchions are exposed on front face of riser.

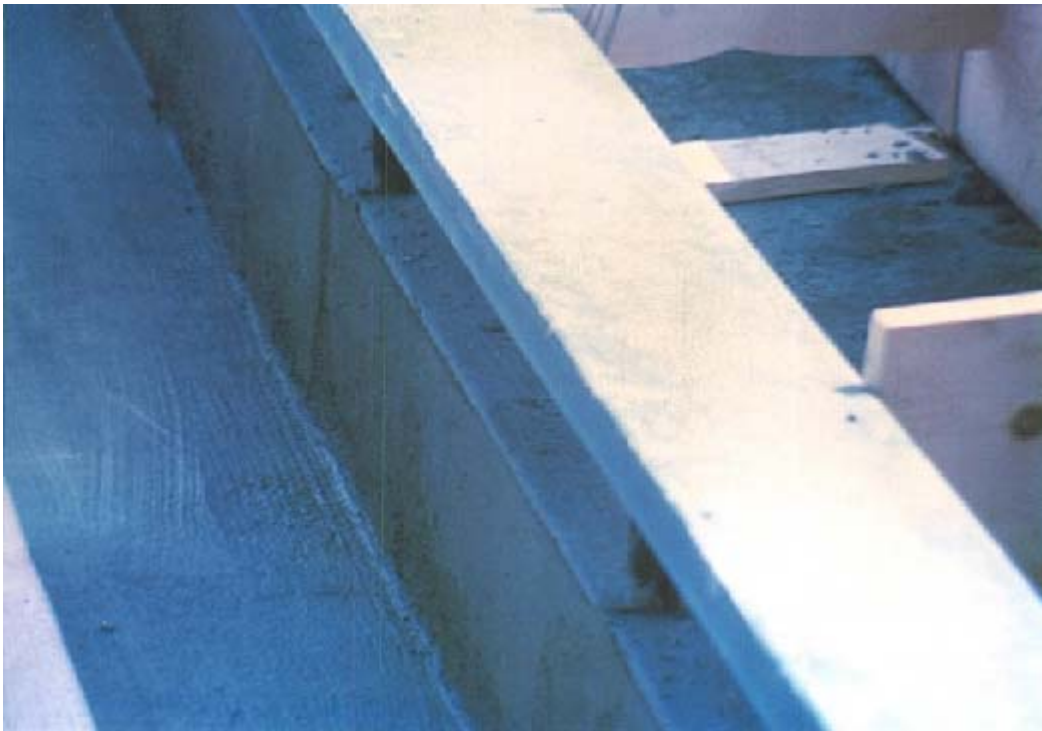
Photograph taken circa 1973 - 1974 concurrent with construction. Forming changed so that stanchions are embedded.

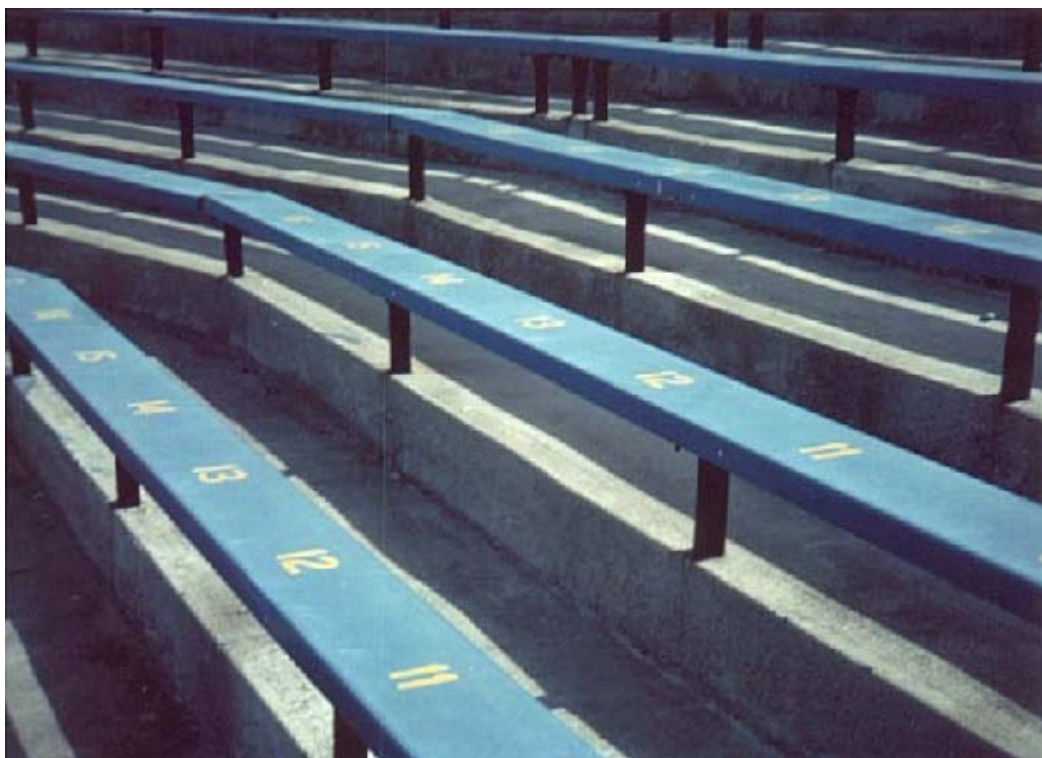
Photograph taken April 1990.
Note embedded stanchions. This method was used after 1972 for the balance of the project.

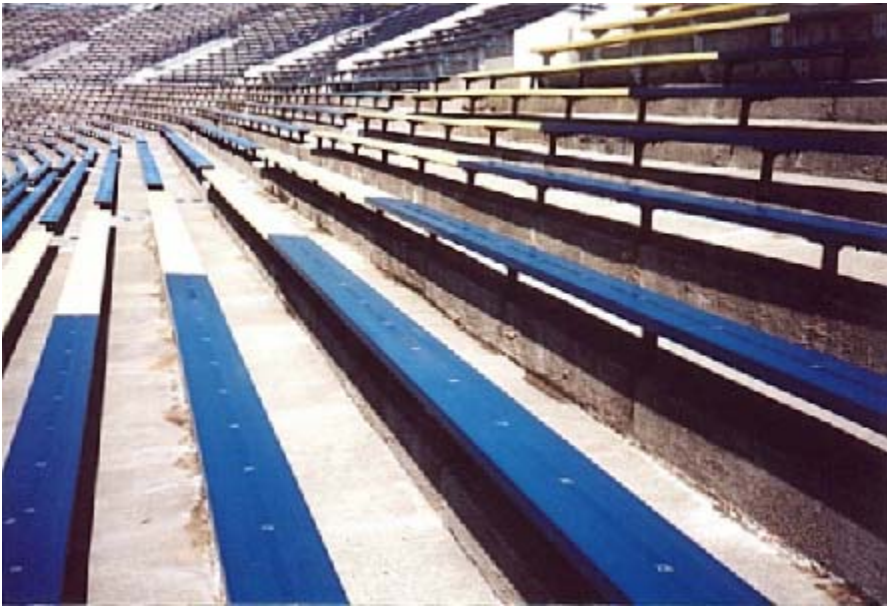
March 13, 2001 – View of east side, showing current condition of repairs done in 1970's with IPANEX Modified repair mortar.

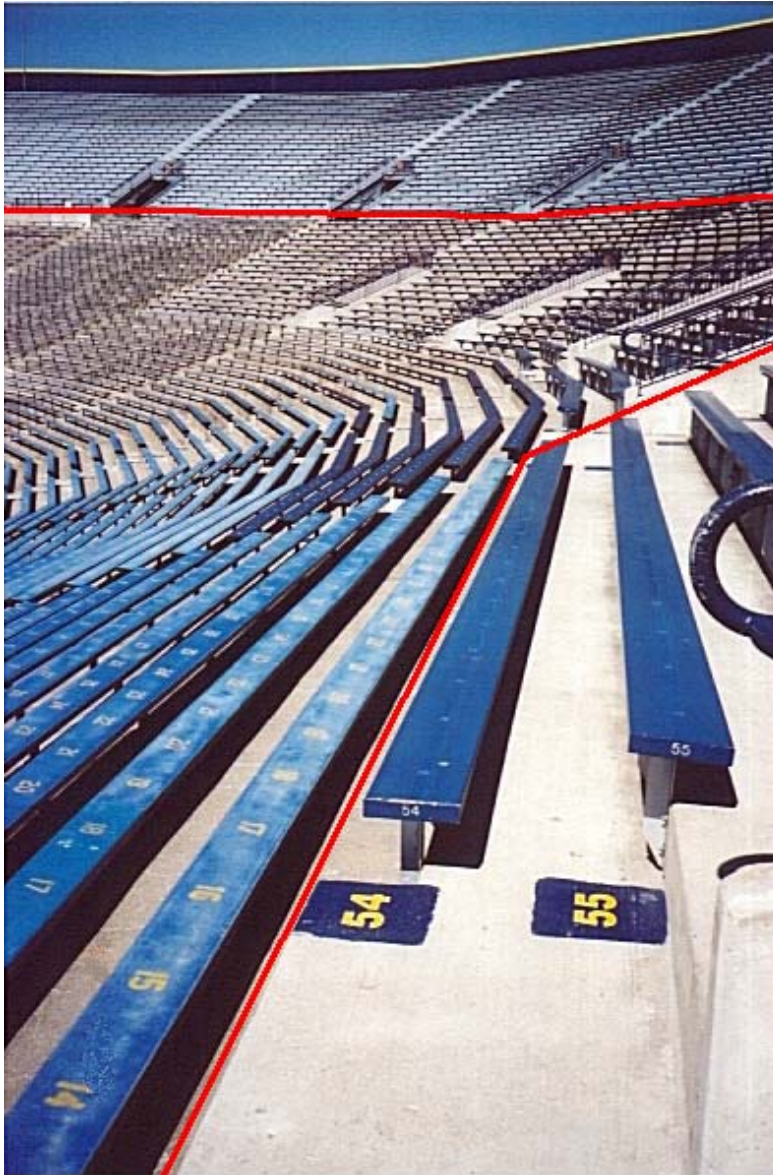
March 13, 2001 – New and old as indicated.

Repair mortar placed circa
1972 – 1979, Rows 1 - 70

New concrete section on East
side (approximately three
sections). These sections
were replaced as part of a
structural rehabilitation of
exterior columns and
beams. Completed in the
1990's.

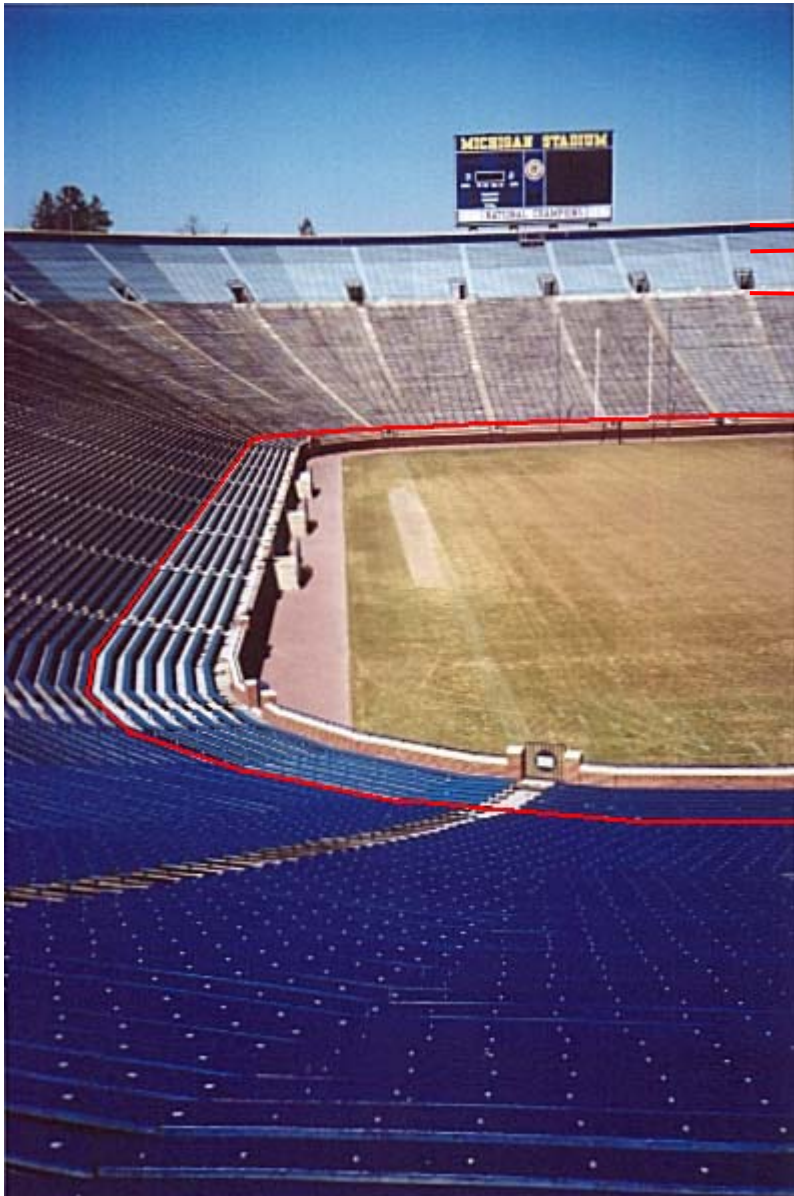
March 13, 2001

Since completion of the repairs in 1979, this photograph clearly shows results of two major projects completed in 1990 and 1998. In 1990 the playing field surface was lowered by 3½ feet and six rows of seats were added. The 1998 project added seating at the top of the stadium, approximately 5,000 additional seats. Seating capacity 1979 - 101,500; 1990 - 102,500; currently - 107,000.
