Technical Bulletin No. 5

CORROSION PROTECTION OF IPANEX CONCRETE COMPARED TO MICROSILICA CONCRETE

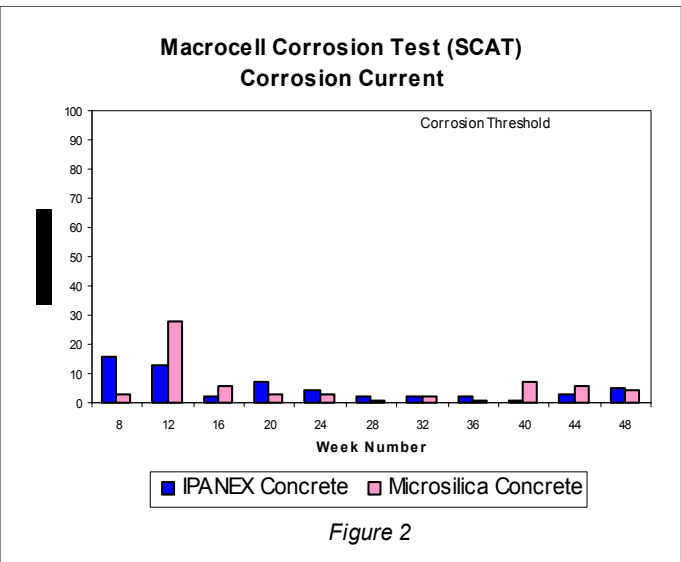
The vertical bar graphs in Figure 2 show corrosion current in microamperes at four week intervals throughout the forty eight week test. Very low currents indicating no corrosion of bars in either the IPANEX or microsilica concrete were observed.

Corrosion currents (Figure 2), copper-copper sulfate half cell potentials (Figure 3), and chloride ion contents (Figure 4) are shown on the following graphs.

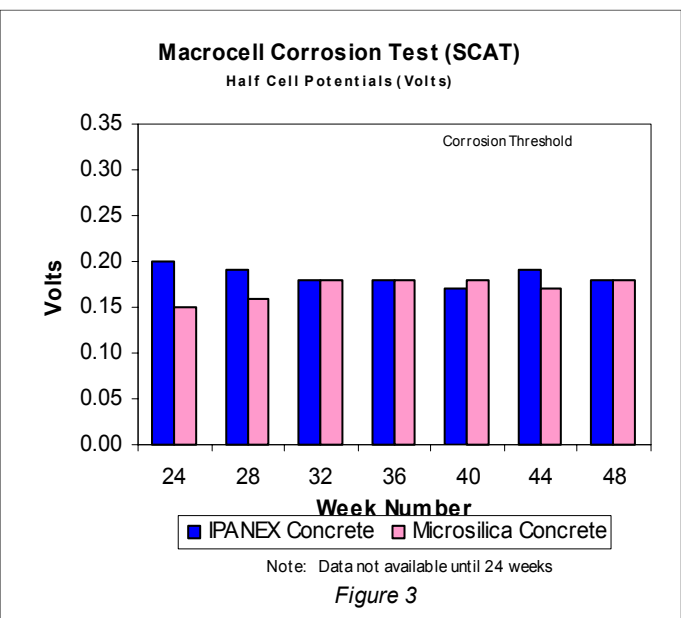
The vertical bar graphs in Figure 3 show half cell potentials at four week intervals from weeks twenty-four to forty-eight. Earlier data is not included because copper-copper sulfate half cell was not available. Electrical half cell potentials are taken to determine the corrosion activity of the reinforcing steel. The significance of the numerical values of the potentials measured (according to ASTM C876) is as follows:

- If potentials over an area are more positive than -0.20 V CSE, there is a greater than 90% probability that no reinforcing steel corrosion is occurring in that area at the time of measurement.
- If potentials over an area are in the range of -0.20 to -0.35 V CSE, corrosion activity of the reinforcing steel in that area is uncertain.
- If potentials over an area are more negative than -0.35 V CSE, there is a greater than 90% probability that reinforcing steel corrosion is occurring in that area at the time of measurement.

Half cell determinations for both IPANEX and microsilica concrete specimens are all below the threshold of corrosion values.

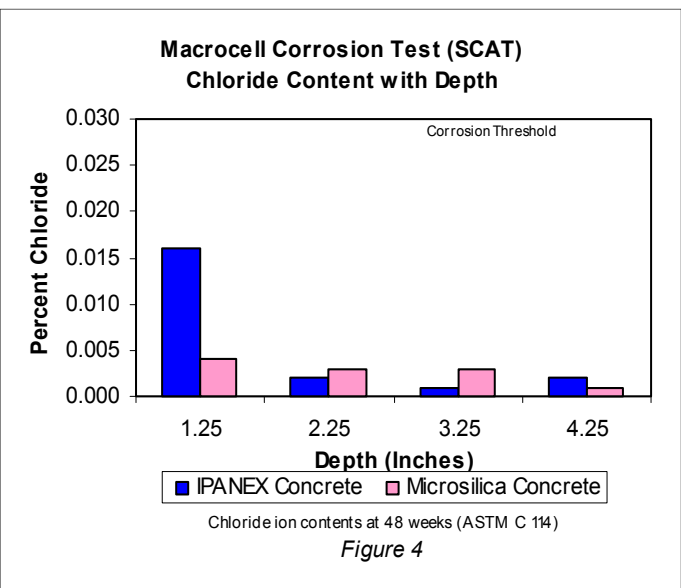
The vertical bar graphs shown in Figure 4 show chloride ion contents as percent by weight of concrete after forty eight weeks of the ponding and drying cycles. Concrete samples were taken by drilling horizontally (parallel to reinforcing steel) at the depths indicated. Data shown are averages of at least three determinations. All chloride ion contents were well below the generally accepted threshold of corrosion.
