Technical Bulletin No. 7

IMPROVED DURABILITY OF IPANEX CONCRETE CONFIRMED BY HOCKING COUNTY, OHIO, FIELD TEST

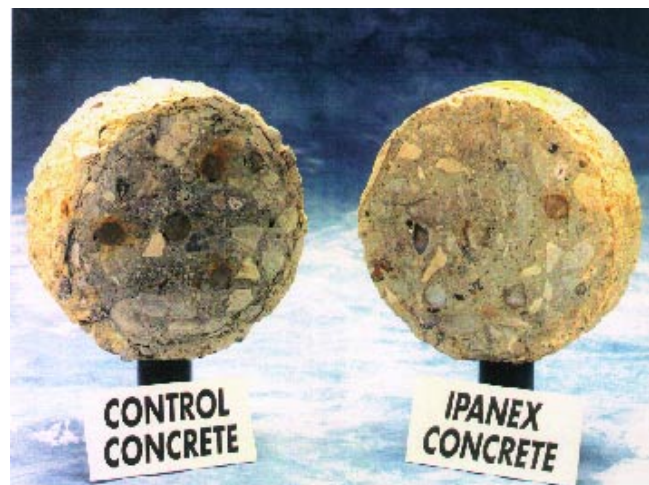
Figure 1. Control and IPANEX concrete cylinders exposed to oil well brines.

Extensive degradation can be observed on the exposed surface of the cylinder leading to the development of onionskin cracking and spalling. The IPANEX specimen exhibits only minor exterior degradation with traces of weakly developed onionskin separation parallel to the exterior surface.

The sub-sectioning in 1995 cut off approximately 4" of the bottom of each cylinder. These sub-sections were used only for visual inspection. Figure 1 is a photograph of the two sections. As can be readily seen, the control concrete possesses signs of severe distress.

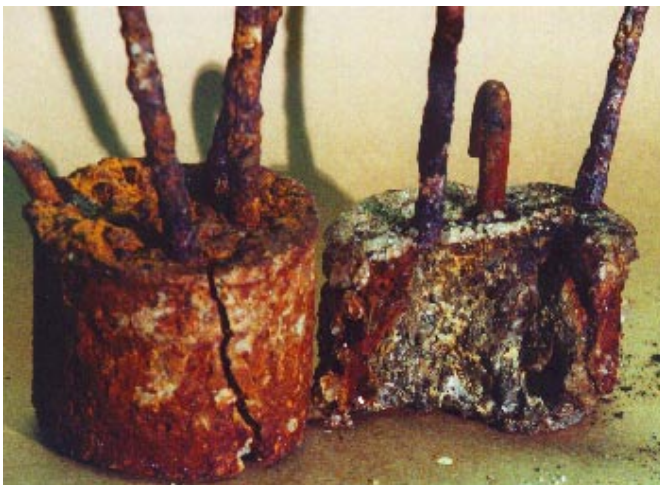
Figure 2. Photograph of IPANEX concrete [left] and the control concrete [right].

On the 14th of August 1999, the concrete specimens and samples of the brine, in which they were stored since the 13th of March 1995, were transferred to the Materials Research Laboratory of The Pennsylvania State University for further characterization. Upon receipt, visual observations showed that the control concrete was experiencing extreme distress. The exterior surface of the remaining cylinder was covered with sodium chloride crystals measuring approximately 2 cm in diameter. A pie shaped segment, still containing one section of rebar, had split off from the cylinder revealing extensive corrosion at the matrix/rebar interface and the development of extensive yellow-white growths on the fracture surface of the concrete, Figures 2 and 3

In contrast, the IPANEX concrete remained intact but was covered with fine brown film, most likely a form of iron oxyhydroxide. During the two-and-a-half months that the specimens sat wrapped in plastic exposed to the laboratory environment, several longitudinal cracks developed, however, the integrity of the IPANEX modified cylinder was maintained, Figures 2 and 3.

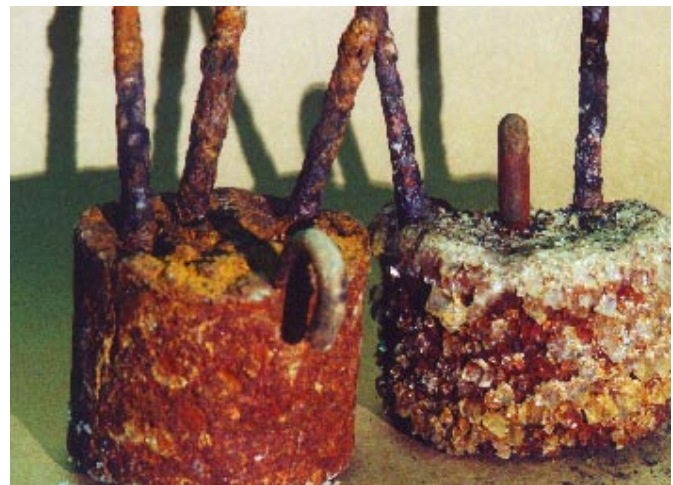
Figure 3. Photograph of IPANEX concrete [left] and the control concrete [right] rotated 180°.

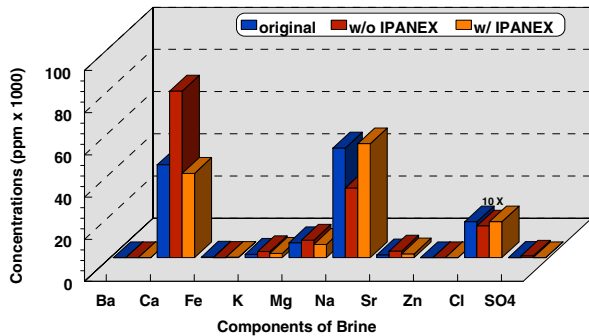
Figure 4 graphically represents the data presented in Table 3. From this table and Figure 4 it can clearly be seen that calcium is significantly increased in the brine for the control concrete and that the IPANEX concrete brine and the original unaltered brine have nearly identical concentrations of calcium in solution.

Figure 4. Brine chemistry contrasting the original oil well brine to the brines that were in contact with the concrete for 4-1/2 years.

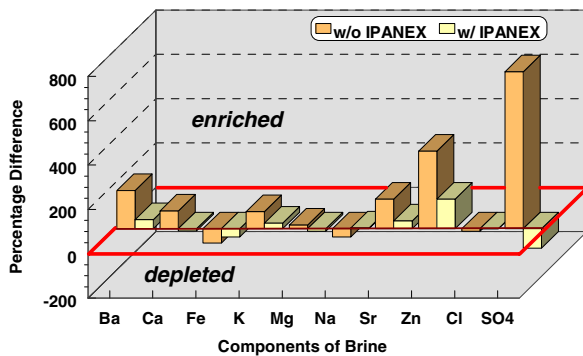
Figure 5. Percentage difference between the solution concentration of elements in the leached concrete samples relative to the original oil well brine.

A careful examination of the data in Figure 5 shows that not only is calcium enriched in the brine from the control concrete but essentially all of the elements except iron, sodium and chlorine also show an enrichment. The depleted elements can be rationalized with respect to their chemical reactions. Iron under these oxidizing conditions will readily precipitate to a ferric oxyhydroxide. The sodium and chlorine depletions can be accounted for in the large mass of sodium chloride salt crystals that decorate the exterior of the control concrete.

In contrast, the IPANEX concrete brine shows only low to modest enrichments associated with the minor and trace elements in portland cement, for example, barium, strontium and zinc. The principal cement-containing elements common to the brines are nearly at the original brine concentrations.

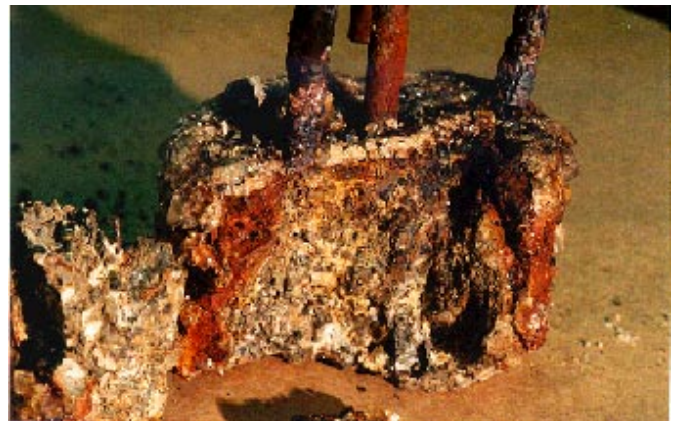
Figure 6. Photograph of the control concrete after alternate exposure to 7 years 3 months in brine and 1 year 3 months in air.

The visual analysis of the two concrete specimens, that were designed and cast in Hocking County, Ohio, and met OHIO DOT specifications, clearly demonstrated that *unprotected* concrete rapidly degrades in the presence of oil field brines, Figure 6. This observation was further supported by the analysis of brine used as a leachate for the samples. Significant enrichments in concentration of the elemental constituents of the concrete are observed dissolved in the brine which contained the control concrete.

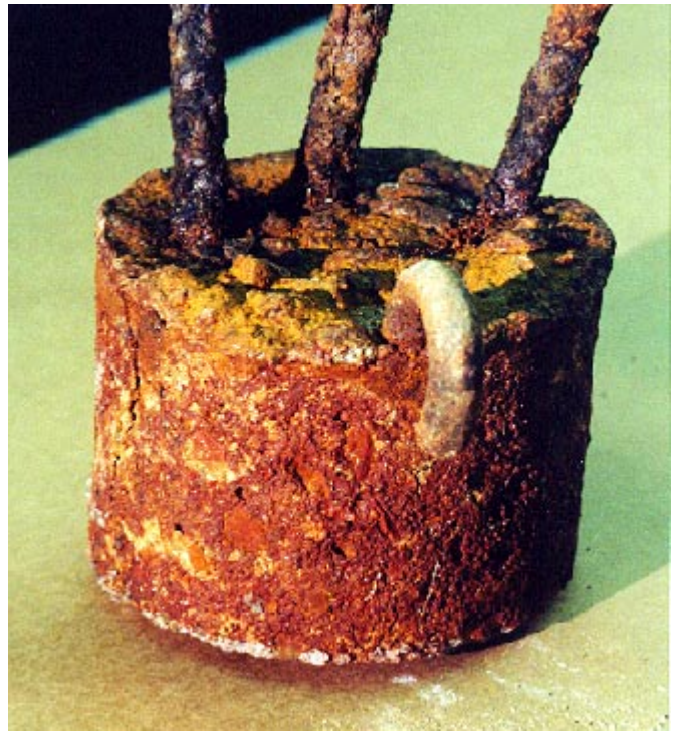
IPANEX concrete, Figure 7, exhibits only minor alteration and minor release of elements from the concrete into the brine leachate after approximately eight-and-a-half years of alternate exposure to immersion in this corrosive oil well brine and freeze/thaw conditions in air.

Figure 7. Photograph of IPANEX concrete after alternate exposure to 7 years 3 months in brine and 1 year 3 months in air.
